# ***NEW JERSEY DIVISION OF FIRE SAFETY***

## ***OFFICE OF THE STATE FIRE MARSHAL***

### **Analysis of Fire Department Emergency Operations During Two Responses to the Same Residence**

**Teaneck, New Jersey  
March 21 and 22, 2005**

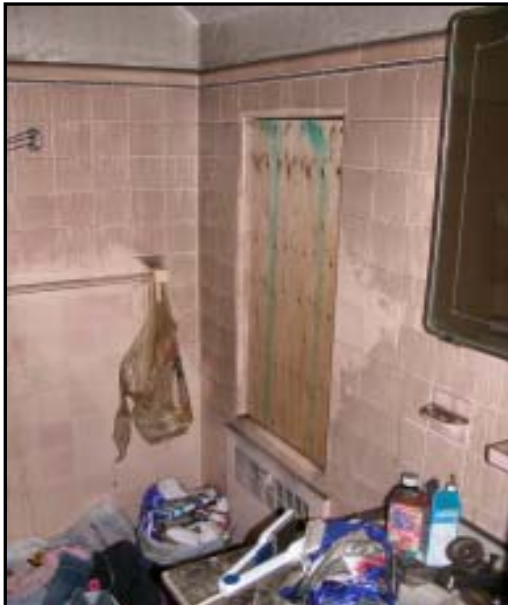
**Figure 3 – An inside view of the second floor bathroom window where two children and their mother were removed from the home.**

The windows in the house generally were steel casement type with center steel partitions. The windows were substantially smaller than what are required in new construction. This made egress and rescue efforts of the occupants much more difficult and time consuming. It was noted that the woman who was rescued from the second floor bathroom window had become wedged and necessitated the forcible removal of the steel window frame to allow her rescue. Additionally, it must be noted that many of the other windows in the home were outfitted with window mounted air conditioning units. Many other windows were partially blocked by large pieces of furniture, such as the bed in the master bedroom that further slowed rescue personnel entering the structure.

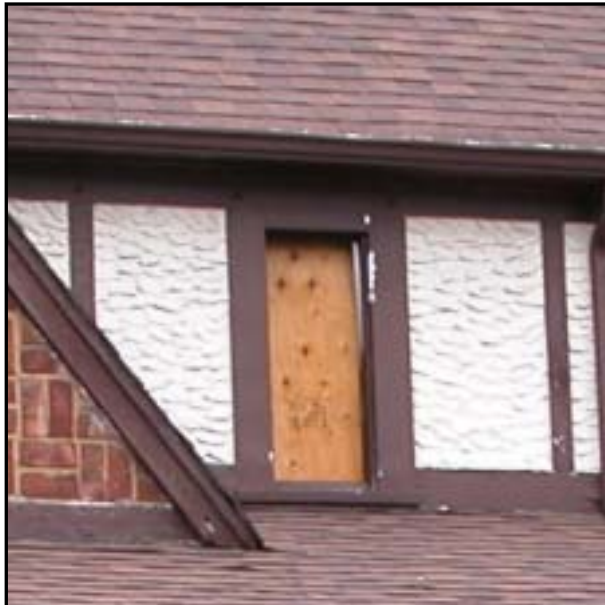
**Figure 4 - An exterior view of the same second floor bathroom window where two children and their mother were removed from the home.**

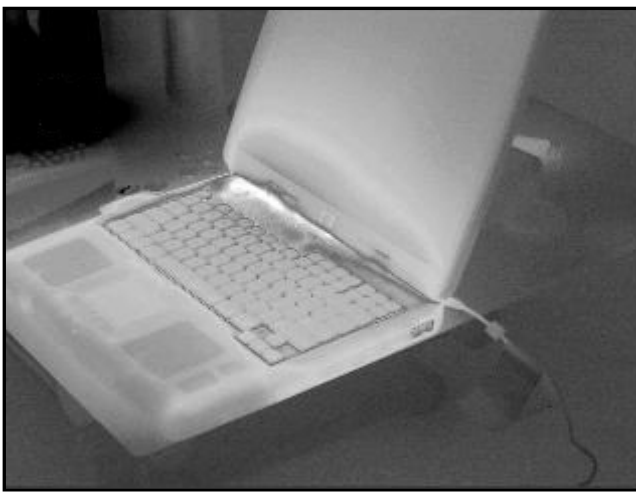
As previously explained in this section and specifically relating to the inability of TICs to "see" through insulated objects, the TIC would not have been an effective tool in locating this overheated fan motor, if it was in fact overheating at the time of the first incident. This is due to the heavy insulation that surrounds the unit. Additionally, the TIC would show the normal heat that is given-off by a properly operating electrical appliance such, would not indicate a problem.

**Figure 5 – An image of a normally operating electrical device, in this case a laptop computer, as viewed by a thermal imaging camera. This illustrates how even normally functioning equipment emits heat energy that is observed by a thermal imaging camera. Note the warmer areas are represented by whiter shades indicating warmer temperatures. Cooler areas are represented by darker shades.**

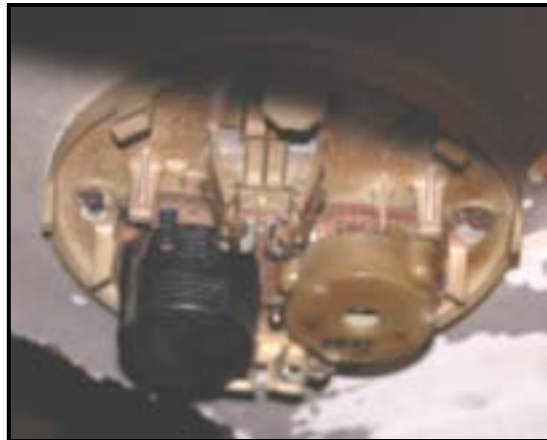
On the early morning of March 22, 2005 only two working smoke detectors were found. These detectors were located on the first and third floors of the home. Other detectors in the home were found to be missing batteries or had been removed completely prior to this incident.

The NJ Uniform Fire Code requires that all one and two family dwellings be equipped with a minimum of one smoke detector on each level of the home. Therefore, this home would have required at least four detectors. The code does not require routine inspection of smoke detectors by code enforcement officials, but rather only when a new home is constructed or upon resale of an existing home. Records obtained during the course of this investigation revealed that at the time of the sale 501 Rutland Avenue in 1998 to the owners/occupants at the time of the fire, working smoke detectors were present and in compliance with the requirements of the NJ Uniform Fire Code.

**Figure 6 – This photograph shows the smoke detector that was located in the basement. It shows that the battery was missing at the time of the fire. This is evidenced by the uniform discoloration of the unit caused by the fire.**

Since the time of these incidents, the TFD has instituted a policy where if firefighters observe deficiencies with regard to smoke detectors in homes that they have responded to, the Fire Prevention Bureau is contacted and personnel will visit the home. They will inspect smoke detectors and install batteries and/or replace the detectors, free of charge. Additionally, the fire department mailed fire safety brochures to all residents and provides voluntary fire safety inspections if requested to do so.
