## ***Firefighter Fatality and Serious Injury Report Series***

### **Seven Firefighters Injured When a Tractor Trailer On Fire Explodes**

**Mansfield Township, New Jersey  
May 31, 2012**

**Report Issued:  
May 1, 2014**

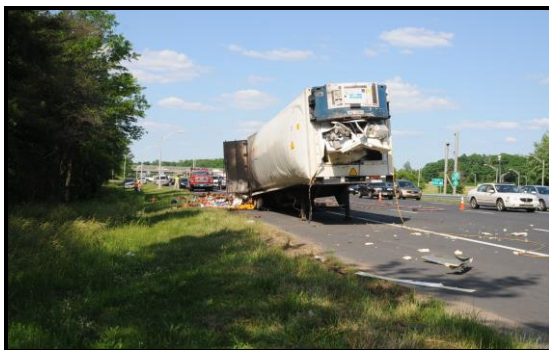
Figure 1 - Front of trailer damage to Refrigeration Unit

The Hazardous Materials Response Unit took samples of the refrigerant from the refrigeration unit located on the front of the trailer. They also took samples of the oily residue located on the interior of the trailer. After laboratory analysis, the oily residue was later determined to be consistent with citrus oil.

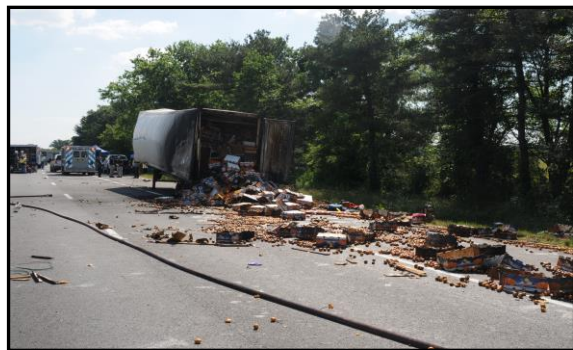
Figure 2 - Rear of trailer showing debris field

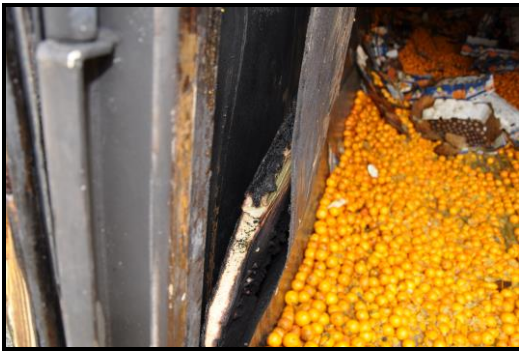
Figure 3 - Foam insulation in wall of trailer

The trailer was approximately 53' in length and had a maximum gross vehicle weight of 74,960 pounds. The exterior walls were constructed of aluminum with approximately two inch thick polyurethane foam insulation. The interior walls were covered with aluminum also. The roof and rear doors contained three inches of polyurethane foam insulation and two and one-half inches of insulation in the floor. The nose of the trailer contained approximately four inches of insulation. The trailer had a cardboard ceiling with holes in it to allow the cold air from the refrigeration system to circulate through the trailer. At the time of the fire the trailer contained 1440 cases of fresh Clementine's weighing approximately 23,472 KG (51,746 lbs.)

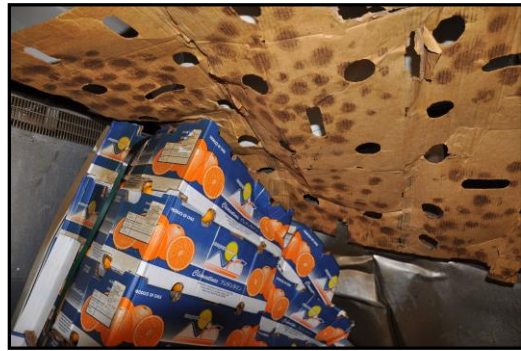
Figure 4 - Cardboard ceiling in trailer

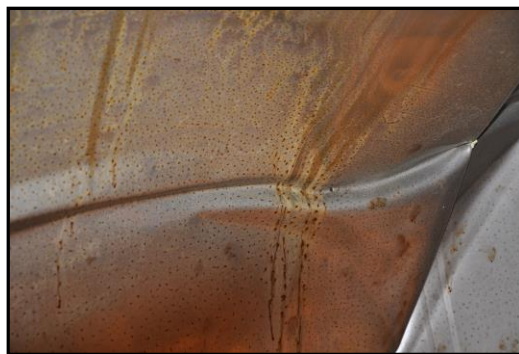
Figure 5 - Oily residues on interior walls of trailer

Laboratory testing by the NJSPHMu of the oily residue located on the interior walls was positive for citrus oil indicating that the fruit had been sufficiently heated and was off-gassing; contributing to the production of smoke and gases inside the trailer. It should also be noted that the clementines were coated with food grade vegetable beeswax and/or lac-resin based wax or resin to maintain freshness. Thiabendazole and/or Imazalil were used as fungicides.

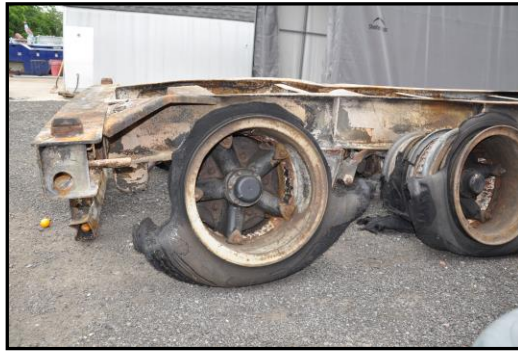
The area of origin was determined to be the passenger side rear wheels. The fire was determined to be accidental in nature. The exact cause of the fire is undetermined due to the fact that the investigation team was unable to identify the first material ignited as well as a possible mechanical failure.

**Figure 6 - Area of origin**

The chassis was observed to have sustained heavy damage in the area of the rear wheels. The tires on all rims were observed to be mostly consumed along with heavy oxidation of the rims. The frame rails on the chassis were observed to be distorted in some areas due to the fire. Due to lack of lighting, further examination of the chassis was to be conducted at a vehicle impound yard at a later date.

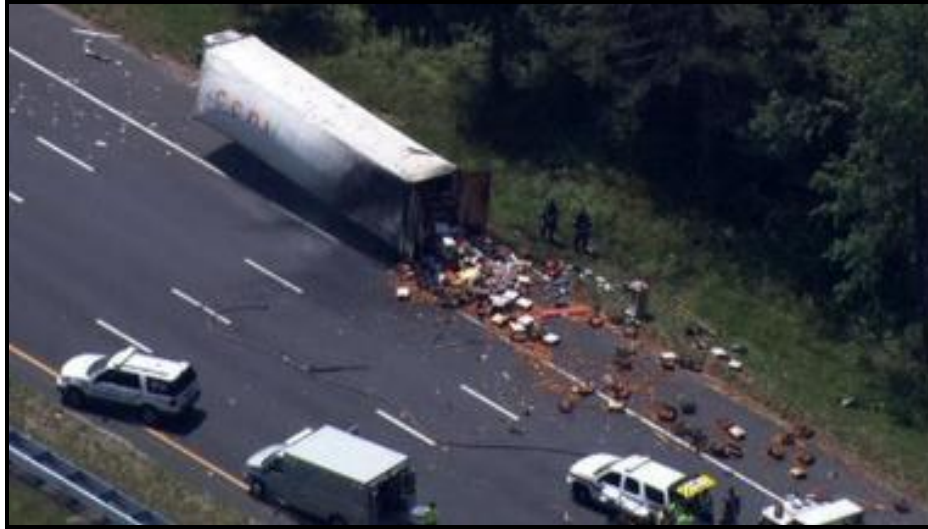
Figure 7 - Aerial view of the scene
