# ***NEW JERSEY DIVISION OF FIRE SAFETY***

## ***OFFICE OF THE STATE FIRE MARSHAL***

### **Analysis of Fire Department Emergency Operations During Two Responses to the Same Residence**

**Teaneck, New Jersey  
March 21 and 22, 2005**

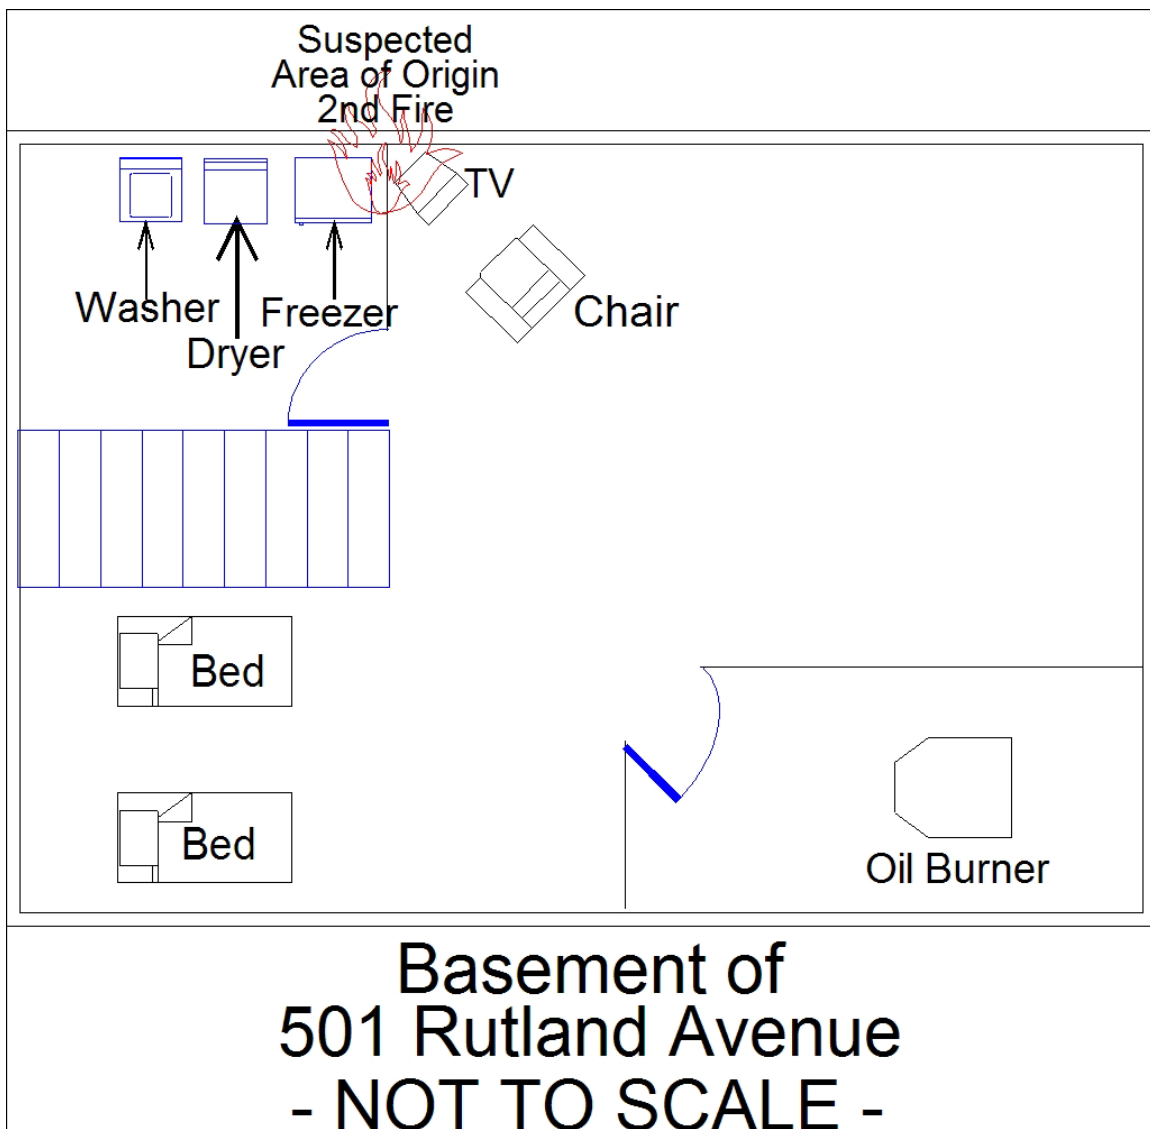
Figure 2

During Lt. Mackey’s check of the boiler, multiple problems were noted. The water level valves were closed and when opened, the water level was too low. The low-water cut-off was found to be inoperable, and the flue damper was dirty. The inside of the fire-box appeared to be okay, but the outside of the boiler around the fire-box was scorched, which is typically a sign of a blowback. Once

DC Palazzola cleared the scene at 8:53 p.m., transferring IC to Lt. Richard Paratore of E-4, advising the mother that Lt. Paratore would let her know their findings. Lt. Paratore then advised her of their findings, recommending that a service technician check the boiler, and telling her to call the fire department again if she noticed any other smoke or odor. The mother agreed with the findings of the TFD personnel, as she stated that the boiler had been serviced multiple times in the recent past to correct problems.
